Report on
Preliminary Contamination Assessment

Proposed Contractor's Car Park
Corner of Fitzroy Street and Mount Street, Goulburn

Prepared for
Hansen Yuncken Pty Ltd

Project 94054.08
April 2020

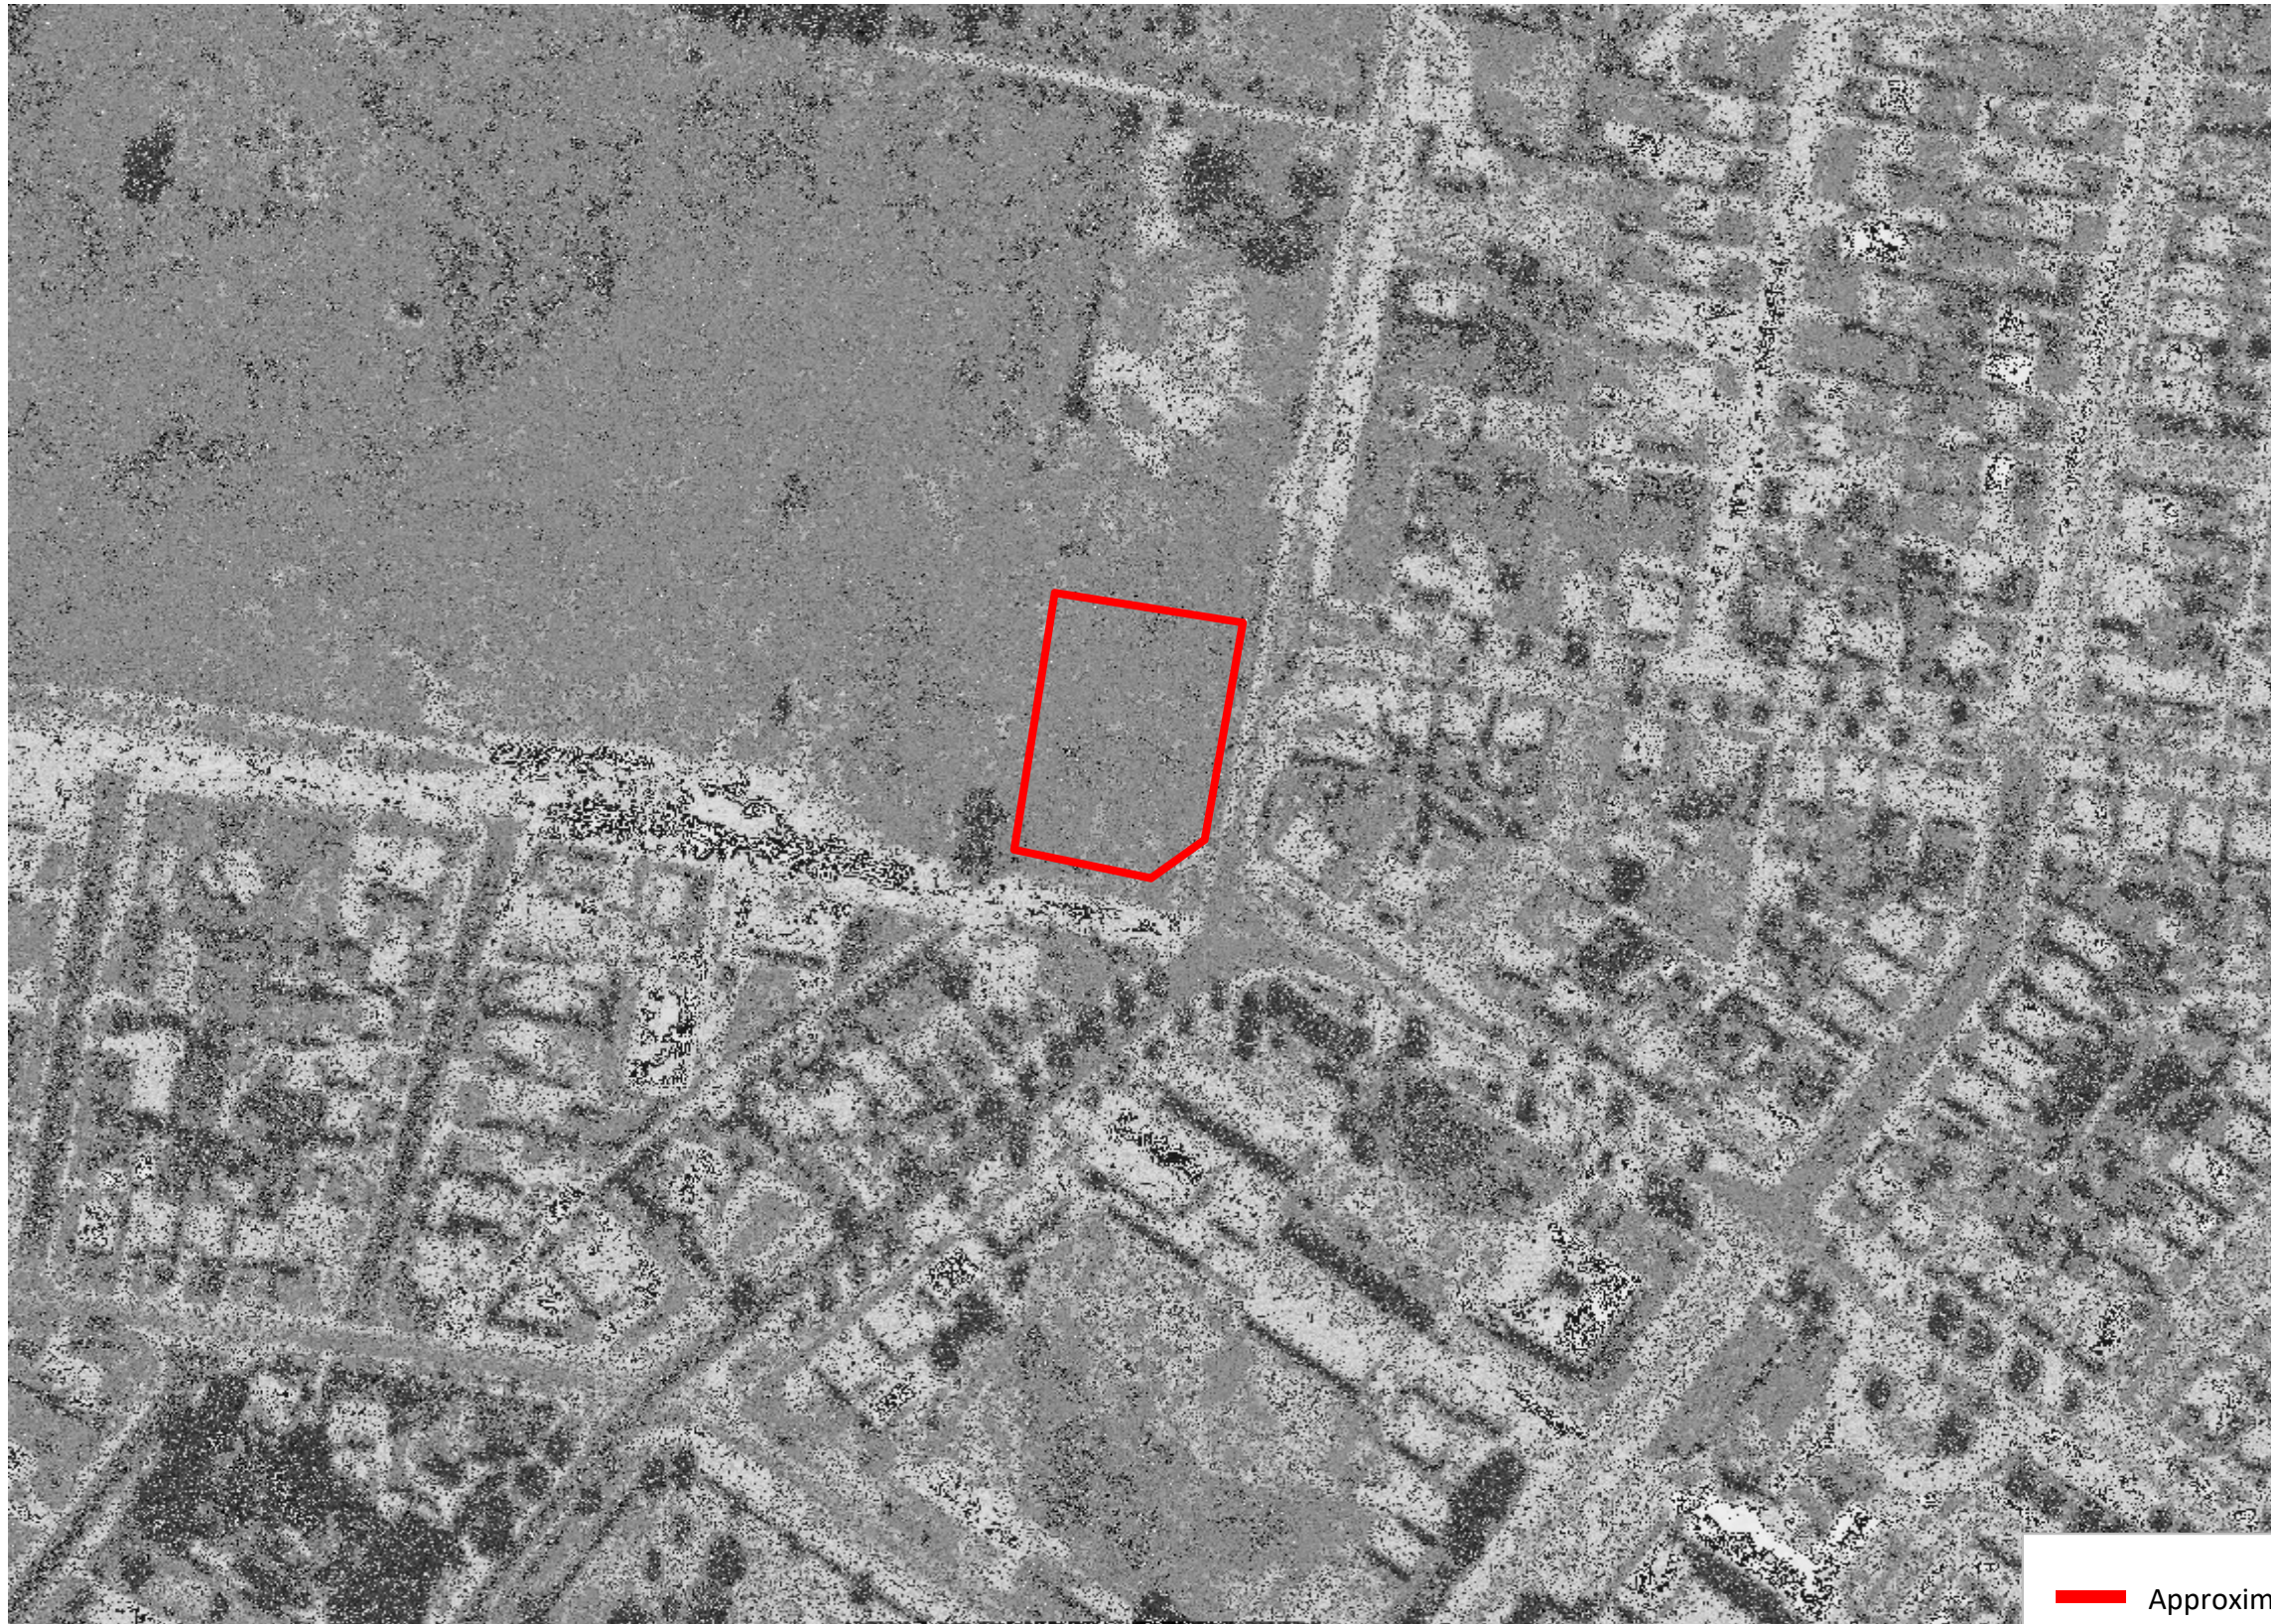
Project No.	94054.08
Plate no	1
Revision:	0

Year	Site	Surrounding Land Use
1967	The site appears to be vacant undeveloped land. Immediately north of the site appears to have undergone some ground disturbance. Immediately east of the site, a footpath and road is observed.	The surrounding land appears to be partially developed for a mix of residential and commercial development. To the north and west of the, site vacant land is observed, to the east and south of the site, a mix of residential and commercial properties are observed. Fitzroy Street is already observed immediately east of the site and the alignment of Mount Street observed immediately south of the site.

Aerial Photograph 1967
Preliminary Contamination Assessment
Proposed Contractor's Car Park, Corner of Fitzroy Street and Mount Street,
Goulburn

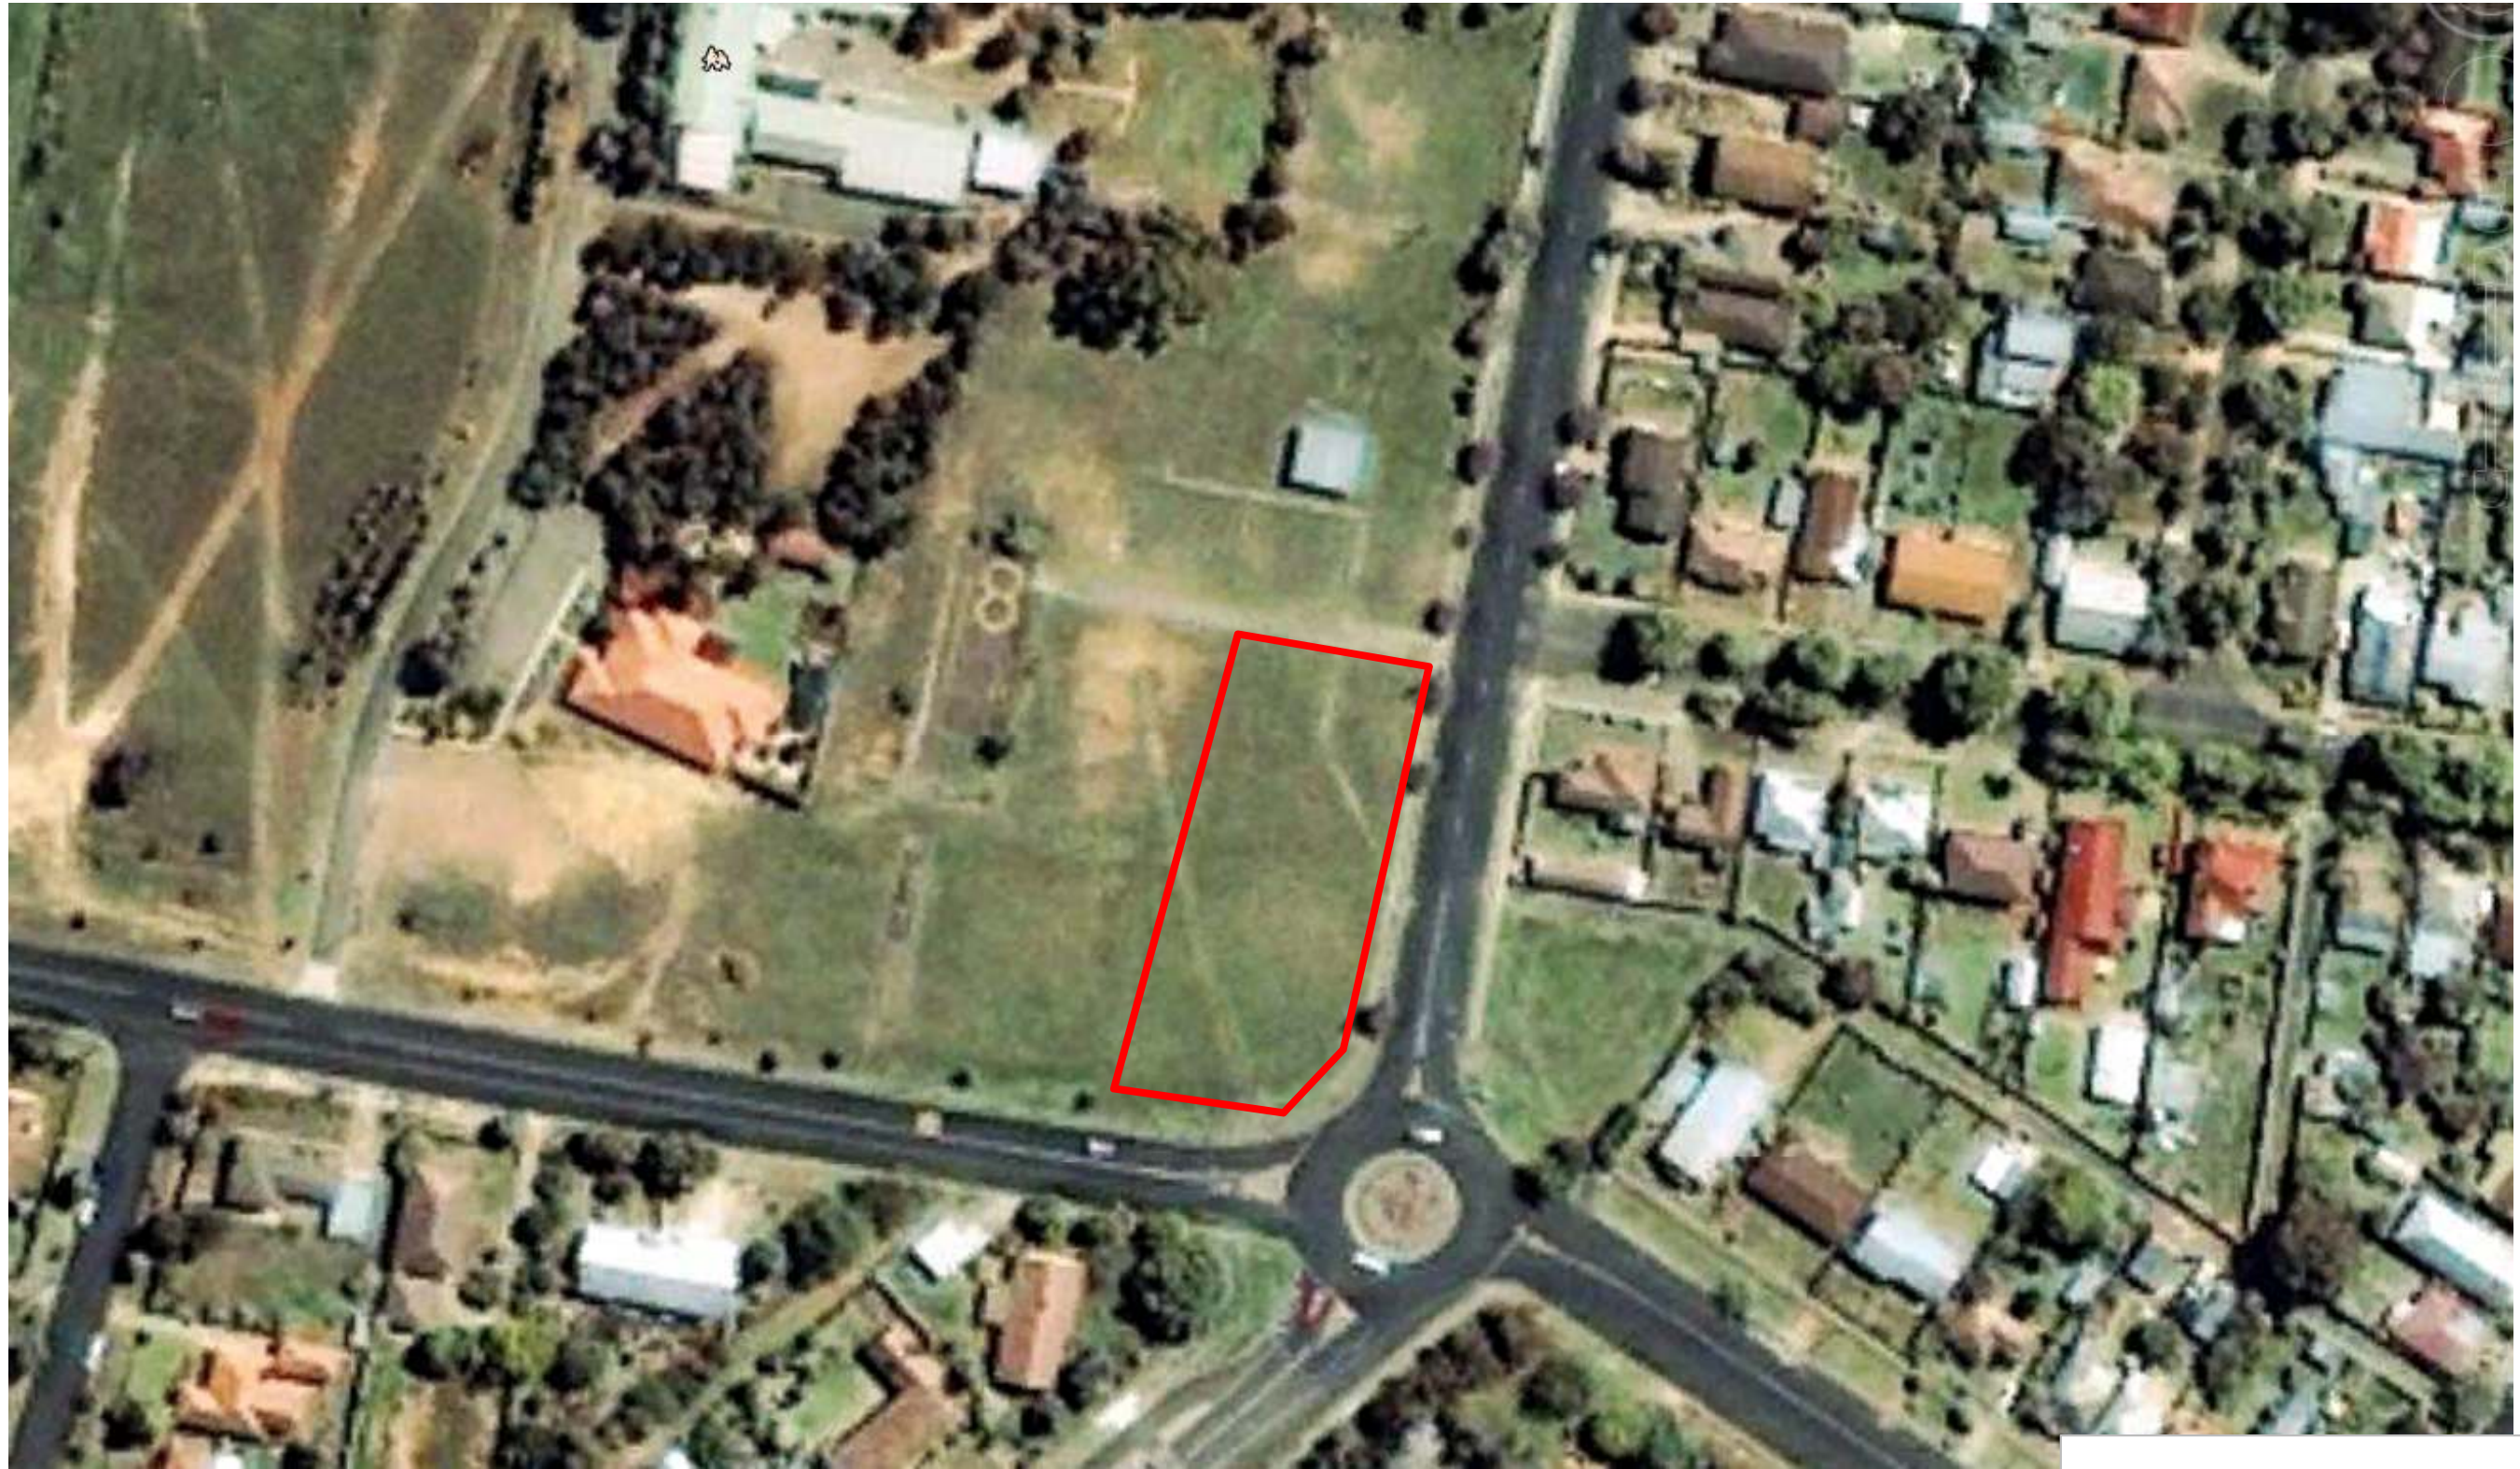
Project No.	94054.08
Plate no	3
Revision:	0

Aerial Photograph 1987
 Preliminary Contamination Assessment
 Proposed Contractor's Car Park, Corner of Fitzroy Street and Mount Street, Goulburn

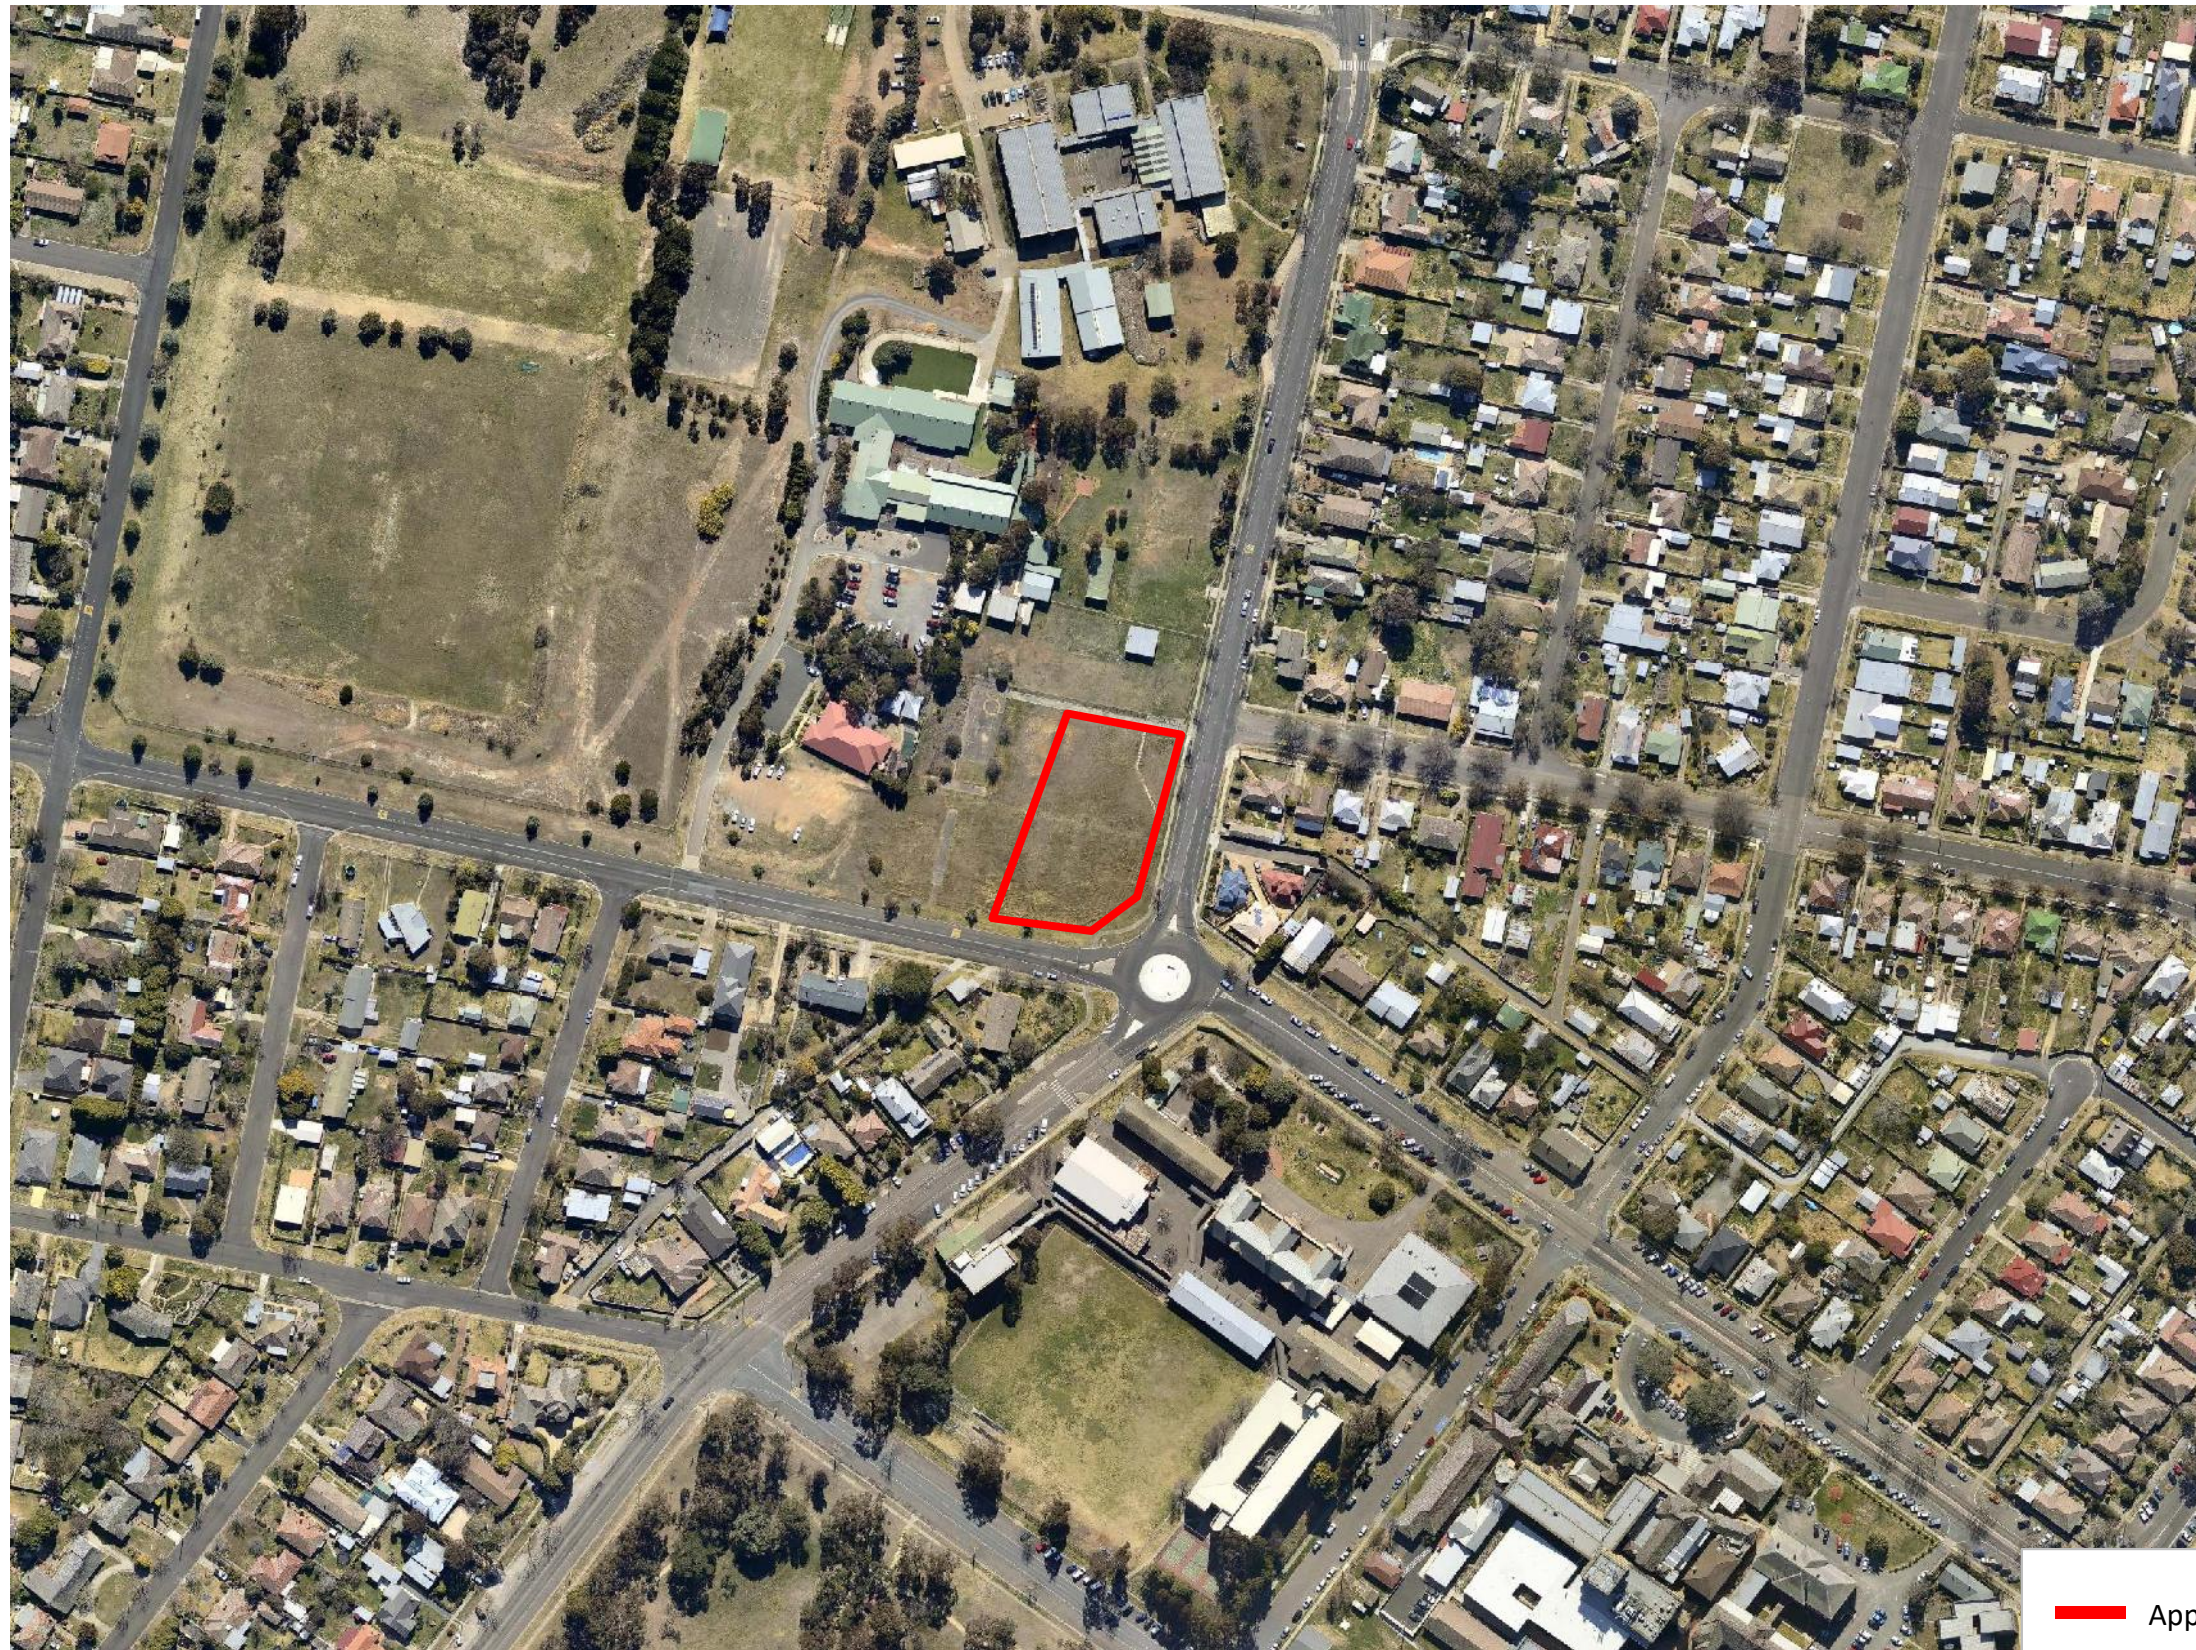
Approximate Site Location

Year	Site	Surrounding Land Use
1987	The photograph appears to be generally consistent with the current site layout. Some development has occurred in the north eastern portion of the site with a footpath now observed. In the north western corner of the site, some ground disturbance is also evident.	The surrounding land use appears to be relatively unchanged. The public school and associated infrastructure and development works is observed to the west and north of the site. Mount Street is also now observed to be developed.
2002	The site appears to be relatively unchanged. The previously observed ground disturbance in the north western corner of the site is now clearly visible with potential trench lines evident running in a north west to south east orientation from the north western corner to the southern/eastern boundaries of the site.	The surrounding land use appears to be relatively unchanged. The school north of the site appears to have undergone further development. To the west of the site, the preschool is now visible.

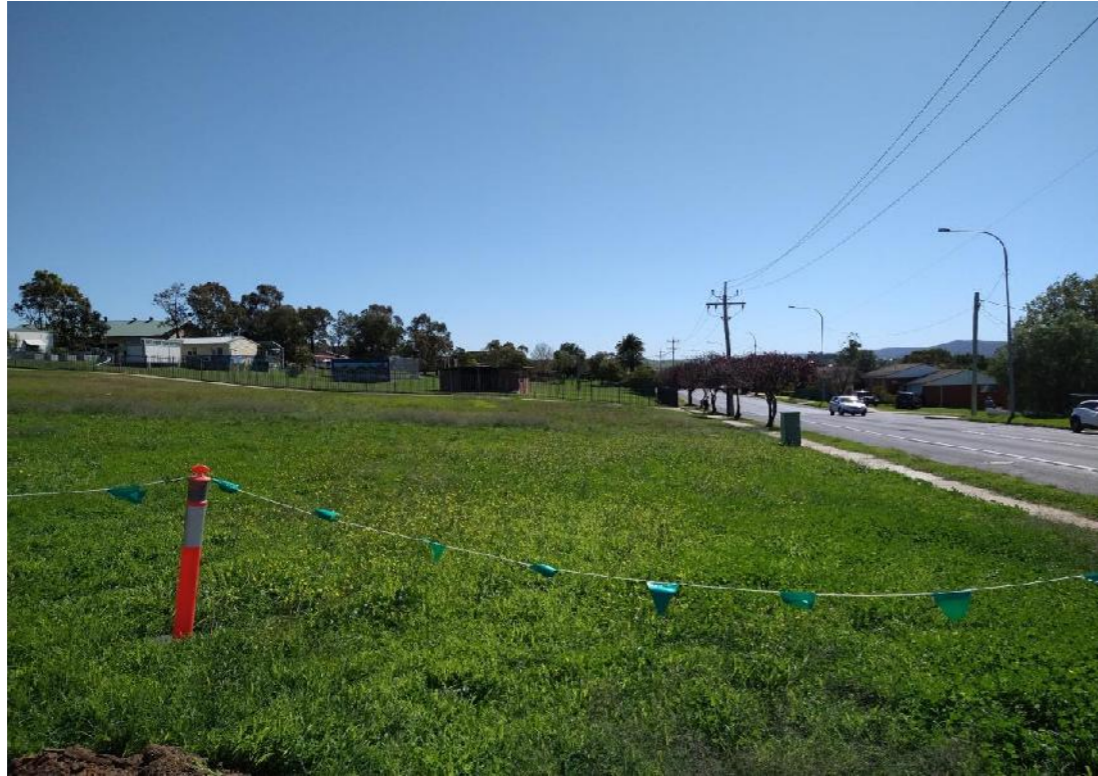
Photo 1: View from south eastern corner of site looking north along eastern boundary.

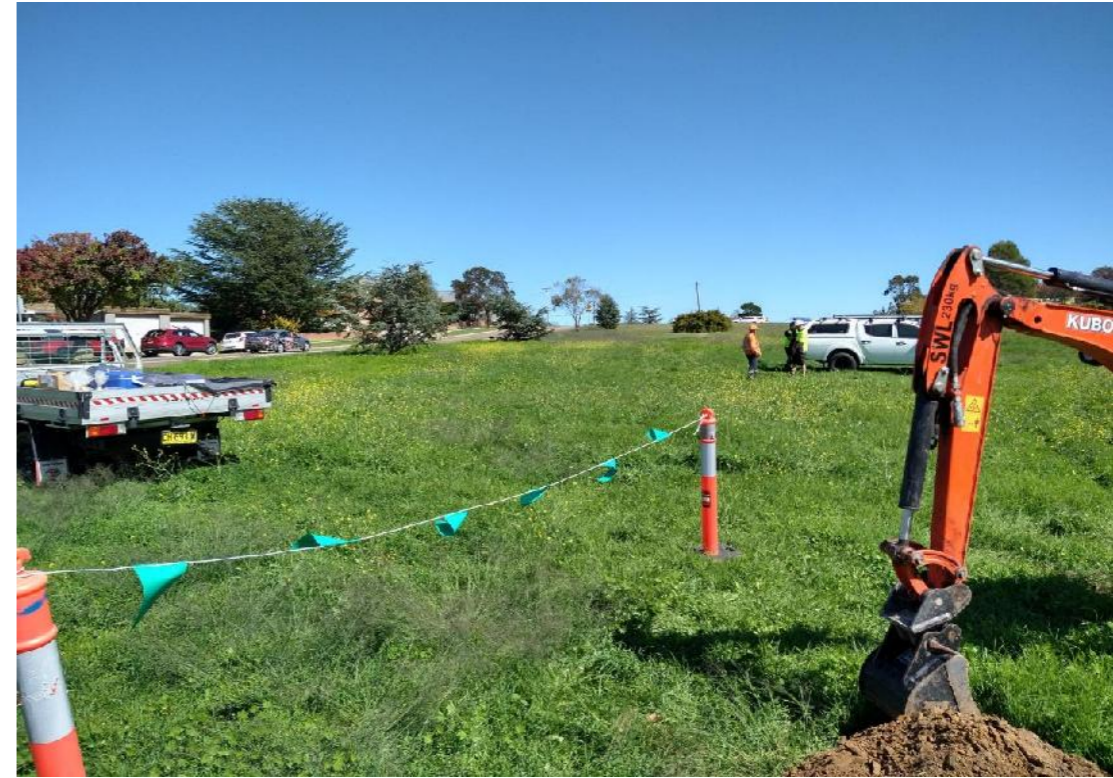
Photo 2: View from south east corner of the site looking west along southern boundary.

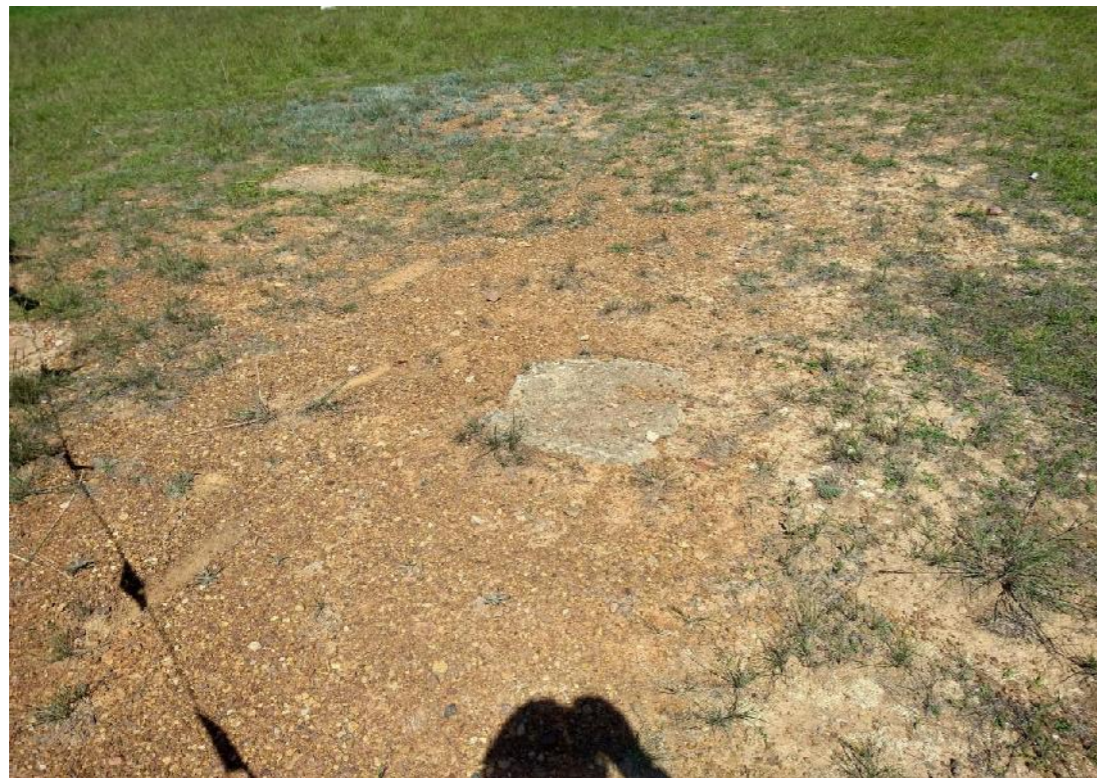
Photo 3: Concrete footings observed in north western corner of the site.

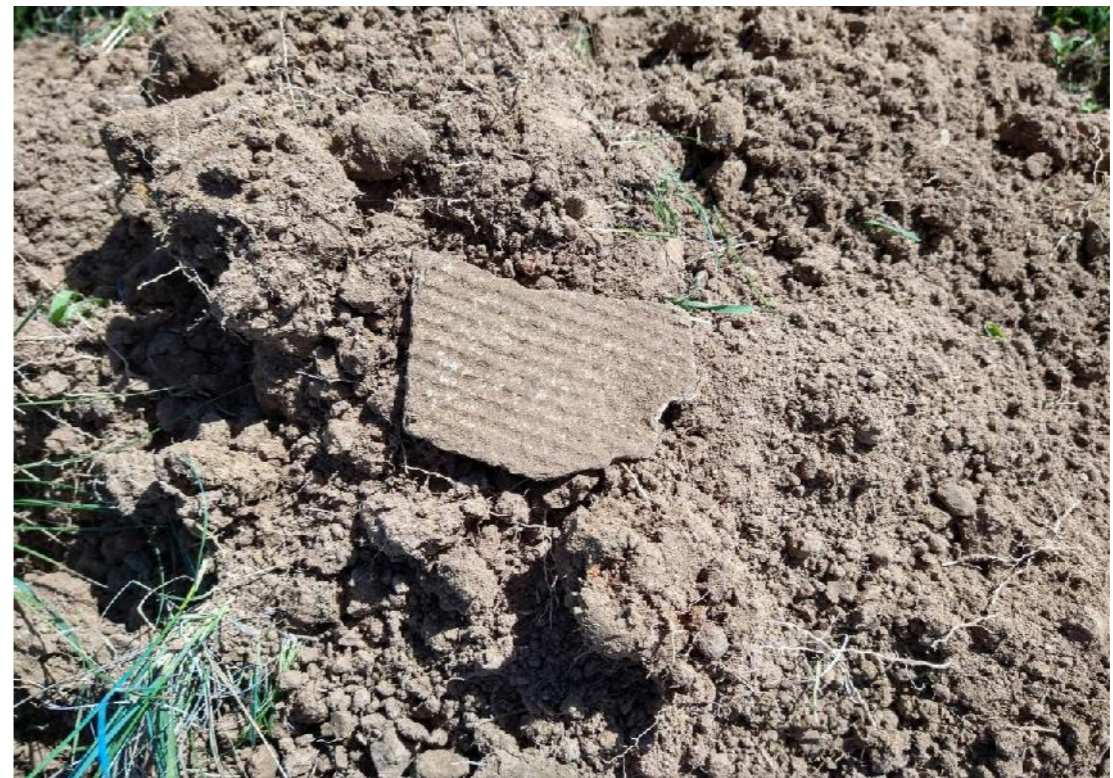
A fibrous cement fragment (suspected to contain asbestos), was observed in the subsurface fill / topsoil in Pit 8 at a depth 0.1 m bgl. The fibrous cement fragment was included in sample 8/0.1 and submitted to the lab for asbestos analysis.

Laboratory analysis for this PCA comprised nine primary soil samples and one intra-laboratory replicate sample. All the reported analytical results were below the adopted SAC for a commercial use. It is noted that asbestos including FA and AF has been detected via laboratory analysis, which is deemed to be friable asbestos.

Photo 4: View of asbestos fragment observed in the fill in Pit 8.

Given that the proposed commercial development will consist of some form of hardstand car park and given that no other asbestos or construction and demolition waste was observed in any of the test pit locations, it is considered there is a generally low risk to identified receptors from the asbestos encountered. If further confidence is required regarding the contamination status of the site a detailed asbestos investigation could be undertaken.
